**Flood Control Project Maintenance
Levee Inspections**

Fall 2016 Levee Maintenance Deficiency Summary Report

Reclamation District No. 0544 Upper Roberts Island

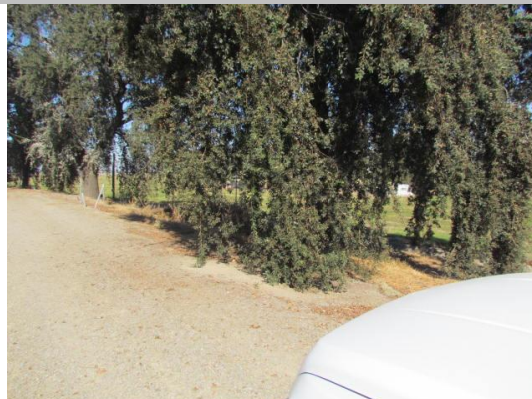
Photo 1 of 1 : FA_2016_RD0544_109_61_20160929_00052.jpg

LM Start	2.28	Rating **	U	Issue No.	61
LM End	2.28	Issue Type +	Ma	Location *	LS
Category	Earthen Levee			GPS Latitude/Longitude	
				Start	End
Item	Trim / Thin Trees			37.821473 °	37.821473 °
				-121.346860 °	-121.346860 °
DWR ID	DWR_RD0544_02_s_2015_61				
Comment Code					
T1 : Trim trees to at least five feet above ground level.					
Inspector Comment					
Untrimmed tree on landward shoulder.

Looking west at untrimmed trees on landward slope fall 2015.

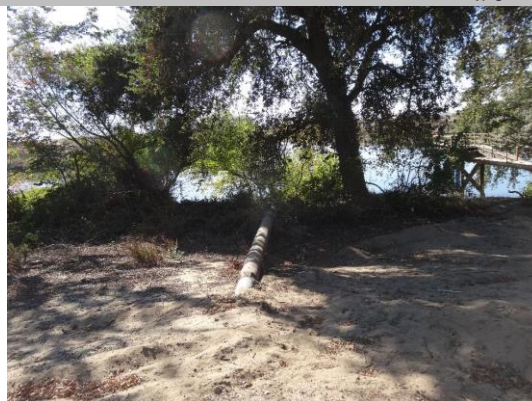
Photo 1 of 2 : UCIP_FA_2016_24293_42965.jpg

LM Start	2.29	Rating **	M	Issue No.	74
LM End	2.29	Issue Type +	En	Location *	LS
Category	Supplemental			GPS Latitude/Longitude	
				Start	End
Item	DWR UCIP Field Study			37.821628 °	37.821628 °
				-121.347016 °	-121.347016 °
DWR ID					
Comment Code					
Inspector Comment					
FS_ID:24293 DS_ID:22676 EP_NO: N/A Repair Type: Non-Urgent Crossing Status: Found UCIP Comments: Pump not found on the landward side. FIELD_STRUCT_DESC: 10-inch steel pipe through the levee, 3.0 feet below the crown. No flap gate on the waterward end. Air vent on landside. O&M Manual SJR 007, April 1964. FS Date: 10/31/2013

WS view: exposed steel pipe on berm.

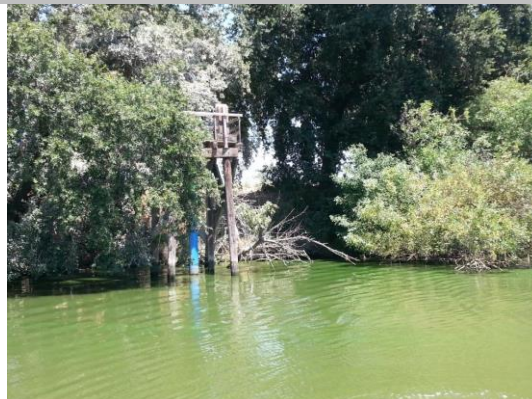
Photo 2 of 2 : SJR2016_RD0544U02RM33.21_3.jpg

LM Start	2.31	Rating **	M	Issue No.	12 (cont)	
LM End	2.31	Issue Type +	Ma	Location *	WS	
Category	Supplemental			GPS Latitude/Longitude		
				Start		End
Item	DWR Erosion Survey			37.821763 °		37.821763 °
				-121.347275 °		-121.347275 °
DWR ID						
Comment Code						
Inspector Comment						
07/25/2016: No significant change observed.						
06/25/2015: No significant change observed.						
07/02/2014: No significant change observed.						
08/20/2013: No significant change observed.						
08/07/2012: The site was first reported in 2012 spring levee inspection report. The data were estimated as the site is underneath a irrigation pump station and inaccessible by boat or land survey. It's possible the pump station played a role in the erosion. [2016 Site ID:RD0544U02RM33.21]

Close view of the site.

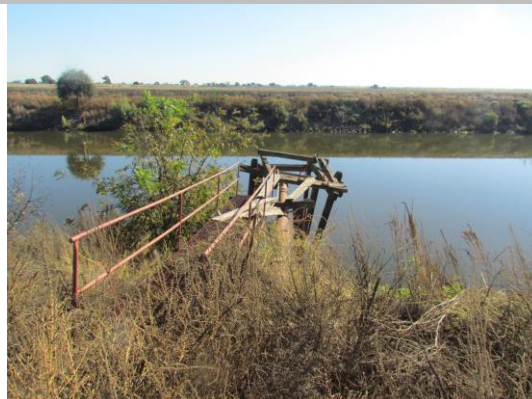
Photo 2 of 3 : FA_2016_RD0544_109_17_20161107_00090.jpg

Looking east at abandoned pump platform. (Fall 2016)

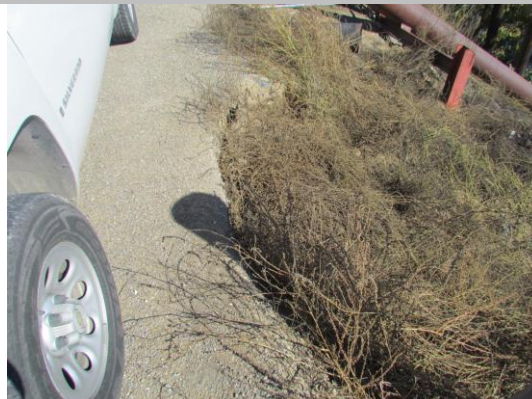
Photo 2 of 3 : FA_2016_RD0544_109_69_20161107_00092.jpg

LM Start	2.61	Rating **	U	Issue No.	69
LM End	2.61	Issue Type +	Ma	Location *	WS
Category	Earthen Levee			GPS Latitude/Longitude	
				Start	End
Item	Erosion / Bank Caving			37.818806 °	37.818806 °
				-121.350437 °	-121.350437 °
DWR ID	DWR_RD0544_02_f_2016_69				
Comment Code					
E2 : Schedule repair of erosion site prior to the next inspection.					
Inspector Comment					
Erosion greater than 1' deep and greater than 3' wide.

Looking north at erosion on waterward shoulder and slope.

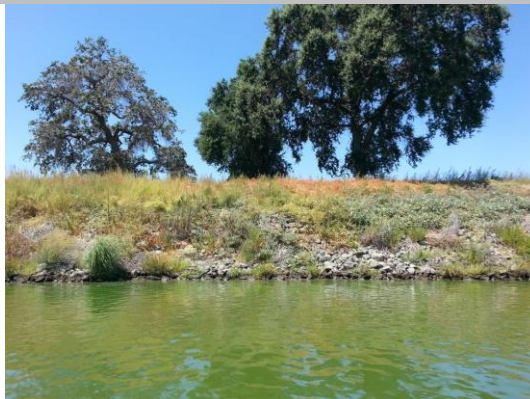
Photo 1 of 2 : SJR2016_RD0544U02RM32.91_1.jpg

Front view of the pocket erosion. Note the vegetation and riprap at the site.

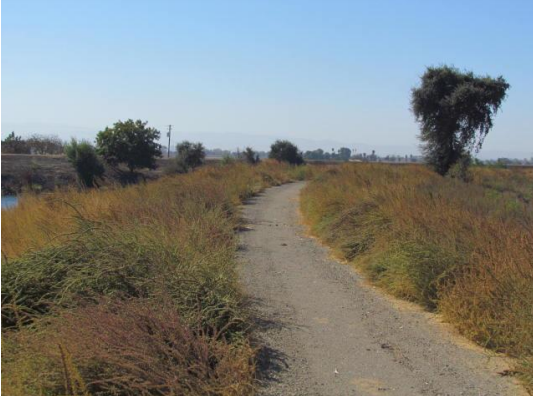
Photo 1 of 1 : FA_2016_RD0544_109_43_20160929_00040.jpg

Looking at dense vegetation on landward and waterward slope.

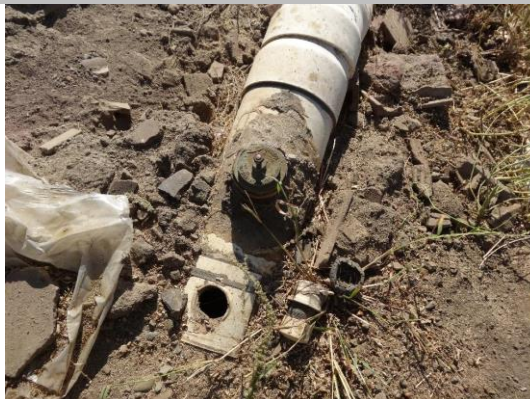
Photo 2 of 2 : UCIP_FA_2016_24908_44897.jpg

LM Start	3.20	Rating **	M	Issue No.	72 (cont)	
LM End	3.20	Issue Type +	En	Location *	WS	
Category	Supplemental			GPS Latitude/Longitude		
				Start	End	
Item	DWR UCIP Field Study			37.818824 °	37.818824 °	
				-121.359526 °	-121.359526 °	
DWR ID						
Comment Code						
Inspector Comment						
FS_ID:24908						
DS_ID:22679						
EP_NO: 16972						
Repair Type: Non-Urgent						
Crossing Status: Found						
UCIP Comments: Pump not found on the waterward side.Damaged pipe-plug on waterside. Pipe exposed on both sides of the levee.						
FIELD_STRUCT_DESC: 1 of 2: Two 8-inch pvc pipes (replaced two 8-inch steel pipes) through the levee, 2.0 feet below the crown. Siphon breaker on waterside. Pump on steel platform in drainage ditch. (App. No. 16972 - Joseph & Gayle Muller)						
FS Date: 10/31/2013

WS view: 8" white pvc pipe with siphon breaker on levee shoulder. An unplugged hole on the pipe.

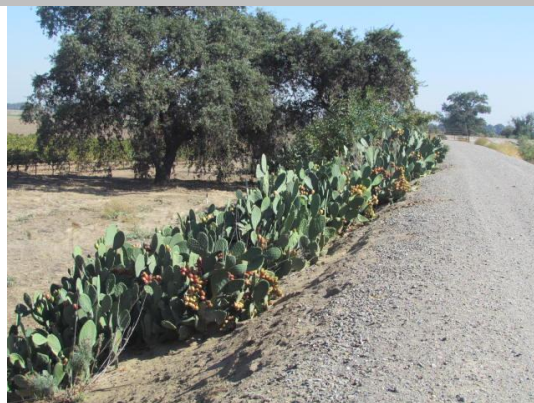
Photo 1 of 3 : FA_2016_RD0544_109_36_20160929_00035.jpg

LM Start	3.48	Rating **	U	Issue No.	36
LM End	3.51	Issue Type +	Ma	Location *	LS
Category	Earthen Levee			GPS Latitude/Longitude	
				Start	End
Item	Vegetation			37.819576 °	37.819530 °
				-121.364056 °	-121.364653 °
DWR ID	DWR_RD0544_02_s_2012_36				
Comment Code					
V2 : Remove the wild growth other than native grasses from the levee slopes.					
Inspector Comment					
Cactus on landside slope.

Looking northwest at cactus on landward slope and toe fall 2015

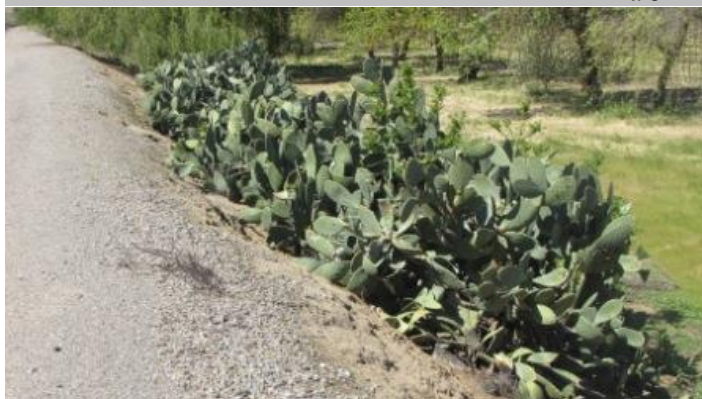
Photo 3 of 3 : FA_2016_RD0544_109_36_20160929_00037.jpg

Looking southwest at overgrown cactus on landside slope spring 2015.

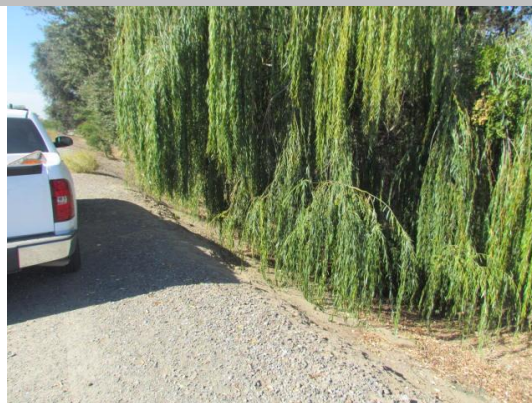
Photo 1 of 1 : FA_2016_RD0544_109_55_20160929_00048.jpg

LM Start	3.49	Rating **	U	Issue No.	55
LM End	3.52	Issue Type +	Ma	Location *	LS
Category	Earthen Levee			GPS Latitude/Longitude	
				Start	End
Item	Trim / Thin Trees			37.819563 °	37.819542 °
				-121.364307 °	-121.364908 °
DWR ID	DWR_RD0544_02_f_2014_55				
Comment Code					
T2 : Thin trees to allow visibility of the ground and room to flood fight.					
Inspector Comment

Looking southwest at untrimmed trees on landward slope and toe fall 2015.

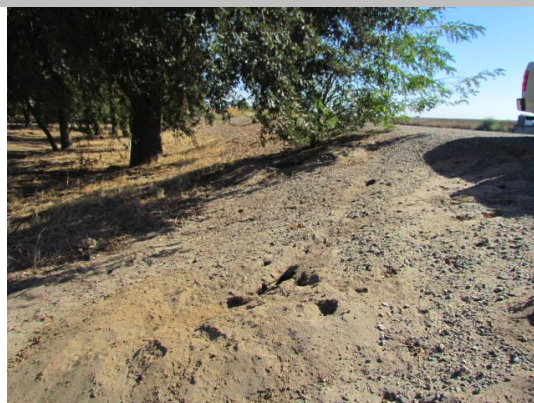
Photo 1 of 2 : FA_2016_RD0544_109_67_20160929_00055.jpg

Looking northeast at typical view of rodent holes on landward slope.

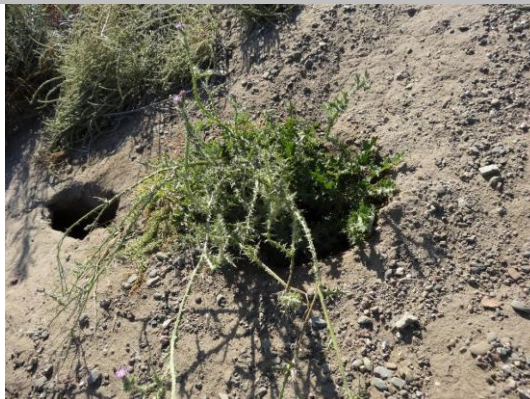
Photo 1 of 2 : UCIP_FA_2016_46064_43005.jpg

LM Start	3.96	Rating **	U	Issue No.	79
LM End	3.96	Issue Type +	En	Location *	LS
Category	Supplemental			GPS Latitude/Longitude	
				Start	End
Item	DWR UCIP Field Study			37.821700 °	37.821700 °
				-121.371752 °	-121.371752 °
DWR ID					
Comment Code					
Inspector Comment					
FS_ID:46064 DS_ID:22674 EP_NO: 16357 Repair Type: Urgent Crossing Status: Found UCIP Comments: Pipe completely rusted thru on WS slope and has potential to cause great erosion. Pit and holes on pipe and levee. No vent pipe found on WS. No concrete vent pipe found at the LS toe. FIELD_STRUCT_DESC: 10-inch steel pipe through the levee, 3.0 feet below the crown. Open on waterside end. O&M Manual SJR 7, April 1964. FS Date: 6/25/2015

WS view: levee slope with pits and holes.

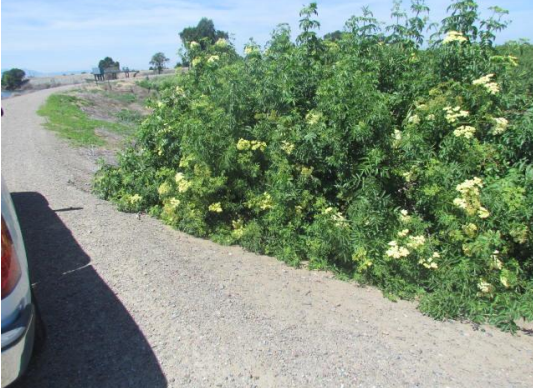
Photo 1 of 1 : FA_2016_RD0544_109_64_20160929_00053.jpg

Looking southwest at dense elderberry bush on landward slope and toe.
(Spring 2015)
